Mobile Intel® Celeron® Processor on .13 Micron Process in Micro-FCPGA Package

Specification Update

August 2003

Document Number: 251309-014

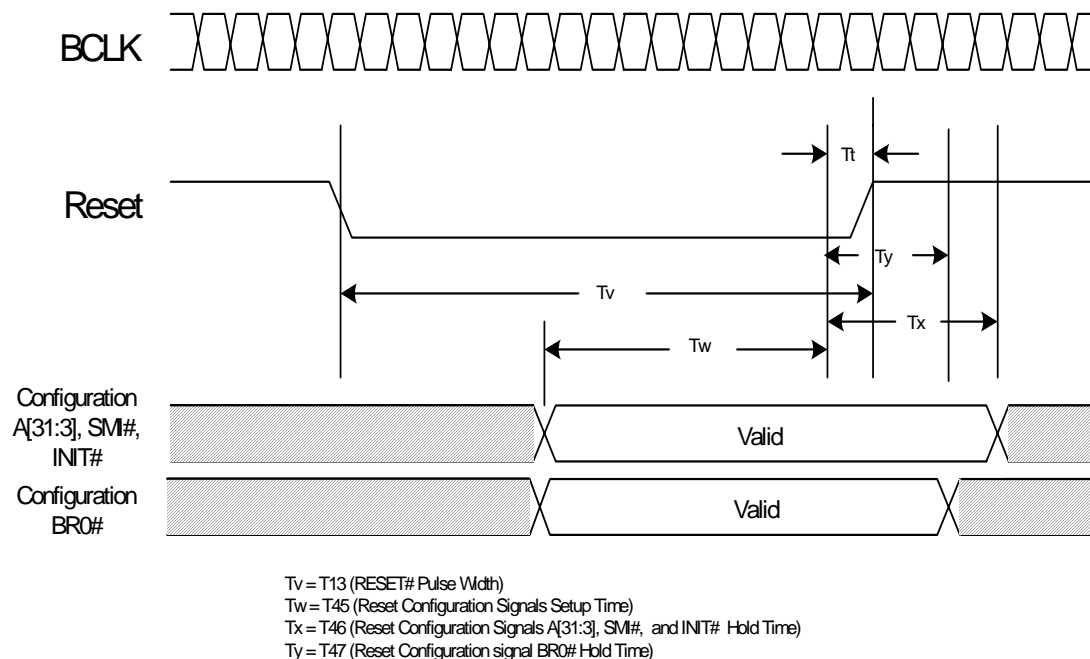
Figure 12. System Bus Reset and Configuration Timings

The BR0# maximum hold time has changed to 2 BCLKs. This change will be shown in the “System Bus AC Specifications (Reset Conditions)” table and “System Bus Reset and Configuration Timings” figure of the *Mobile Intel® Celeron® Processor on .13 Micron Process in Micro-FCPGA Package Datasheet*. This change will be incorporated in the next revision of the datasheet.

The following figure will be modified to reflect this change:
